Manhole Inspection Summary

Manhole # S55G__022MH

Location Address: **rear 3810 bank st**

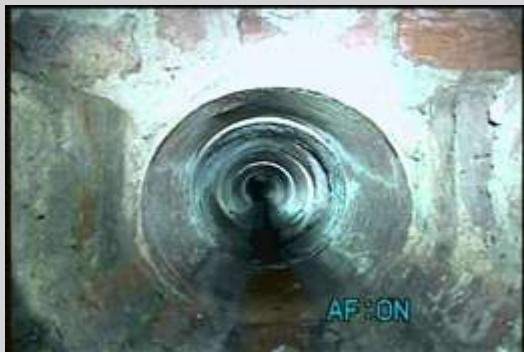
12 O'Clock Outflow

8 in. Circular Gravity Sewer
Pipe Out @ 12 O'Clock

Invert Depth: **6.71** (ft.) Flow Characteristics: **Slow**

Deposits: ☒ None ☐ Mud ☐ Sludge ☐ **Debris** ☐ Grease

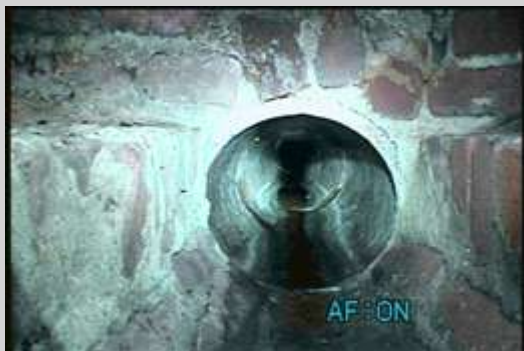
6 O'Clock Inflow

8 in. Circular Gravity Sewer
Pipe In @ 6 O'Clock
